Department of Administration
Construction Update No. 11

**Working From
Top Of East Stairway
To the Bottom ...**

Crews Build Forms, Set Re-Bar for New Support Beams

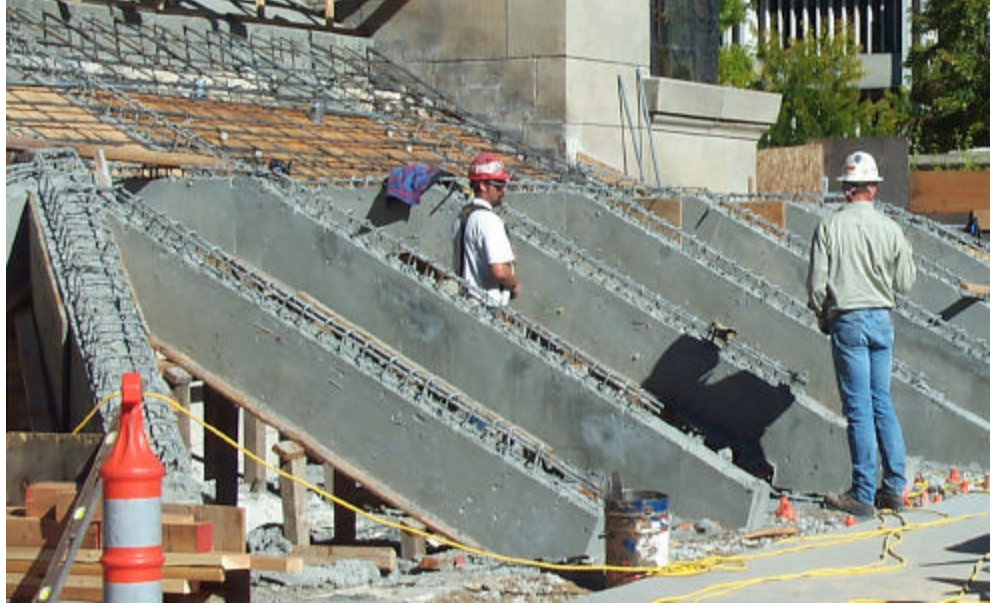
This week's activity on the East Steps Replacement Project continues with the setting of rebar around the new concrete support beams that were poured last week. The re-bar is being set for the pouring of the concrete slab, which will be placed over the storage room under the stairs.

The concrete is scheduled for placement in this area tomorrow, Tuesday (Oct. 16). After this is done the contractor will proceed with building the forms and setting re-bar in the next suspended slabs that will span the support beams already in place. At the same time they will be building the plywood forms for the actual stairs. The contractor is working his way from the top of the stairway to the bottom.
